GOODRICH LIMEKILN (OXFORD ARCHAEOLOGY SURVEY FOR THE OVERLOOKING THE WYE PROJECT)

County	Herefordshire	NGR	58122 18372
Ownership	Coppett Hill, Common Trust	SMR No.	5, 457

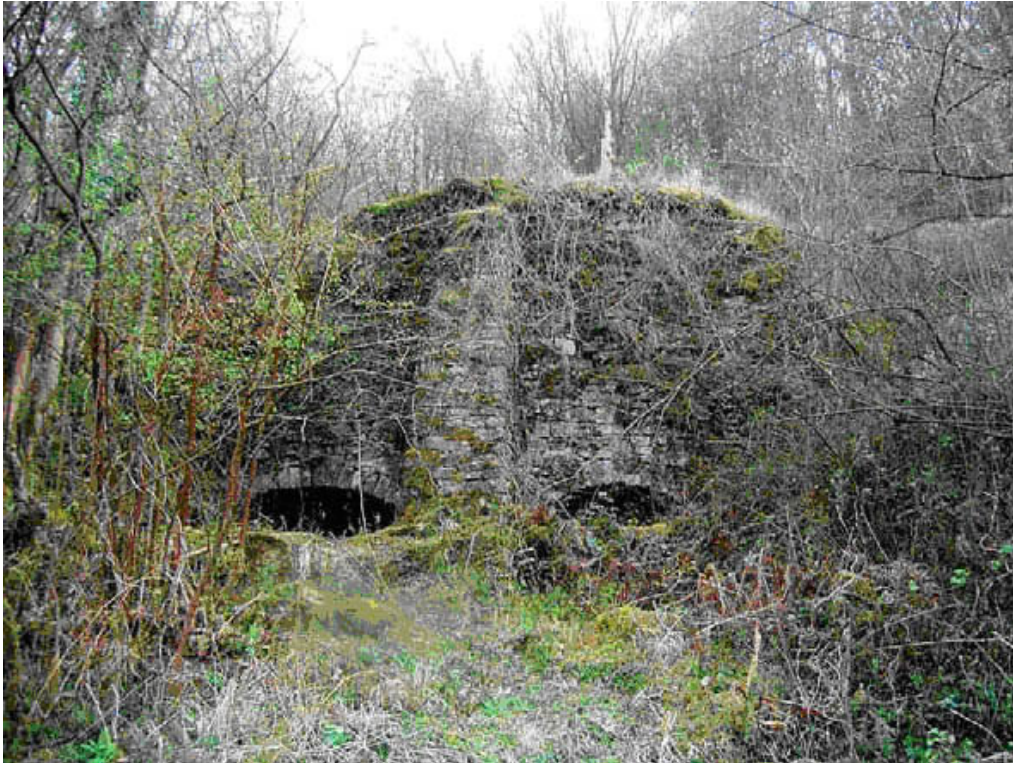
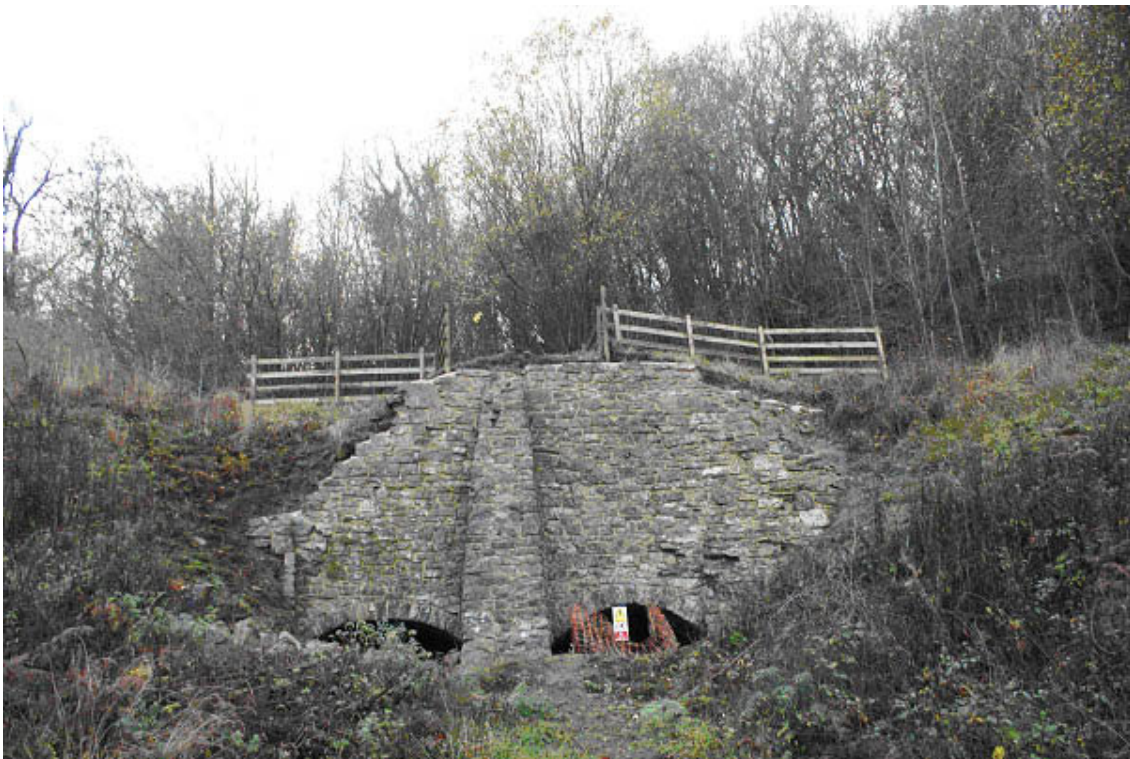
The Coppett Hill Lime Kiln before and after restoration
